Manhole Inspection Summary

Manhole # S07SS_026MH

Insp Date: **1/29/09 10:51 AM**

Location Address: **EDGEWOOD AVE**

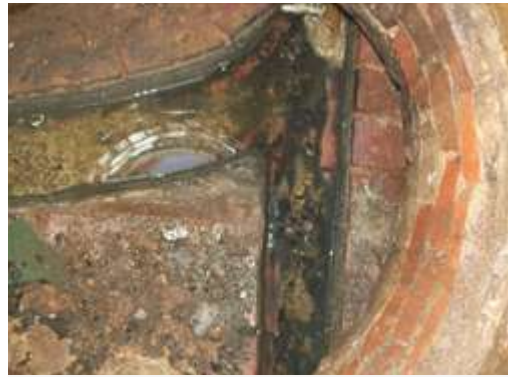
Defect 2

Condition: ☐ Sound ☒ **Cracked** ☐ Root Intrusion ☐ Deteriorated ☐ Leaks ☐ Debris

CRACKED BENCH

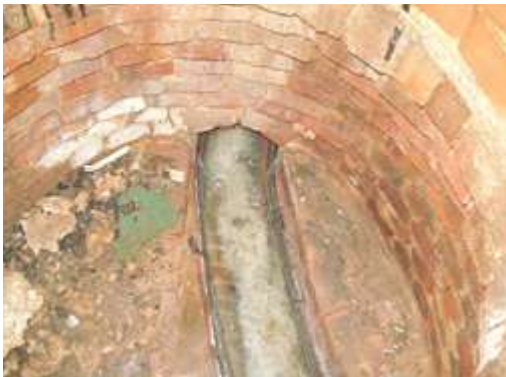
Defect 3

Condition: ☐ Sound ☐ Cracked ☐ Root Intrusion ☐ Deteriorated ☐ Leaks ☒ **Debris**

DEBRIS IN CHANNEL

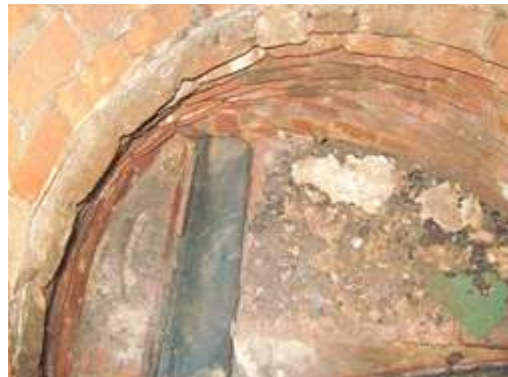
Defect 1

DEBRIS ON BENCH

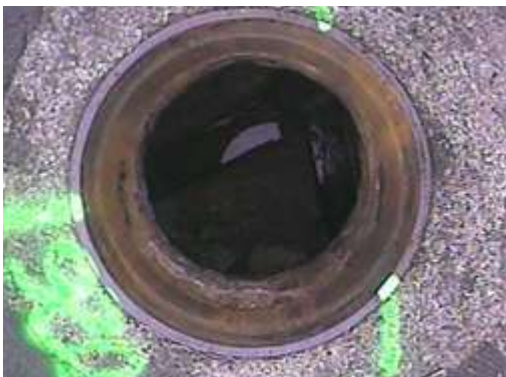
Condition: ☐ Sound ☒ **Cracked** ☐ Root Intrusion ☐ Loose Brick ☐ Deteriorated

CRACKED FRAME ADJUSTMENT

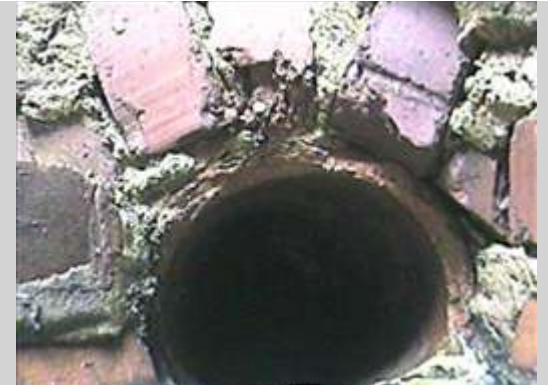
12 O'Clock Outflow

6 in. Circular Gravity Sewer
Pipe Out @ 12 O'Clock

Infiltration: **None** Pipe Seal Cond: **Broken**

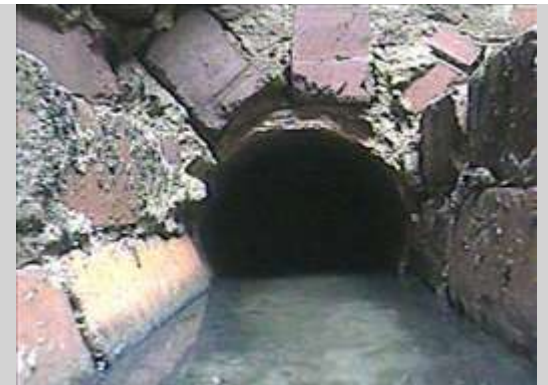
6 O'Clock Inflow

6 in. Circular Gravity Sewer
Pipe In @ 6 O'Clock

Infiltration: **None** Pipe Seal Cond: **Broken**
